PS-13-2020

SERVICE BULLETIN

Subject: Potential Leak - Drain Pump models - Brilliance Cuber/Nugget and CU50

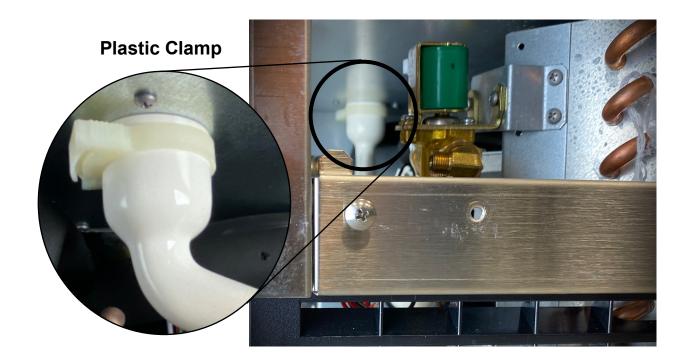
Affected units use a metal worm clamp on the bin drain connection. This clamp may allow water to drip out of the drain tube.

A visual inspection can be performed from the front of the unit. Remove the phillips screw located in the center of the black handle and then remove the front access panel. With the panel removed, look to the back of the unit for the bin drain connection and identify if the unit uses a metal clamp or a plastic clamp.

If the unit has a plastic clamp, no further action is required. If the unit is found to have a metal clamp, the clamp should be replaced with the correct Scotsman plastic clamp, part number 02-2814-13, which will be covered under warranty.
