# SERVICE BULLETIN

**Subject: Prodigy Plus Cuber Design Change To The Right Side Panel**

Applies to all D series cubers models include: C0322, C0522, C0722, C0330, C0530, C0630, C0830, C1030, C1448, C1848 and C2148.

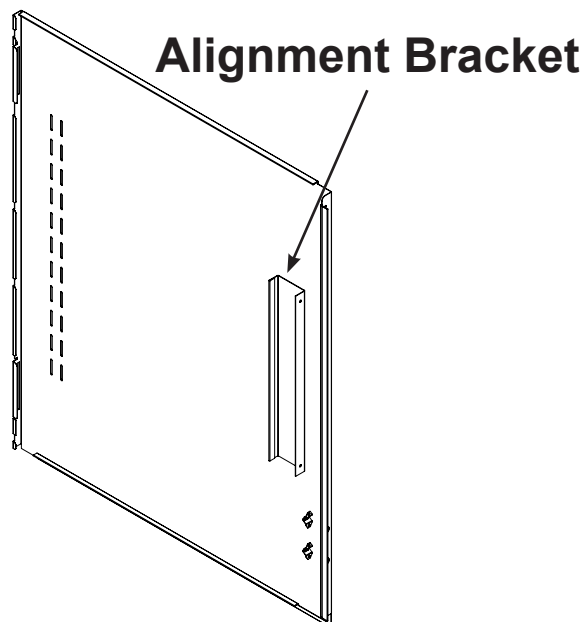
**What changes were made:** An alignment bracket has been added to the right side panel. The bracket is there to ensure that the panel liner is properly positioned.

Units made between Dec 2014 and Feb 2016 do not have alignment bracket.

**Symptoms of an improperly aligned panel liner can include:**

No ice complaint with the controller showing bin full.

- Reduced ice production with the controller showing bin full without a full bin.
- The curtain getting hung up on the panel liner.

**Recommended action:** Units with the above symptoms are suspect to have an improperly positioned panel. To ensure that the panel liner is always properly positioned, order the new right side panels, which include the alignment bracket. The part numbers stay the same and can be found at <http://www.scotsman-ice.com/service/>
